# “Storm Bert” and Flooding on the Site of the Lime Down Solar Park.

## Summary

It is proposed to construct a very large solar farm, called Lime Down Solar Park, in part of the South Cotswolds in North Wiltshire. A named storm, Storm Bert, caused extensive flooding in this area in 2024. This report contains a brief analysis of the rainfall that caused the floods, the effects on flow in the rivers, a comparison with a previous major flood event in November 2012, and an annotated pictorial account of the floods themselves.

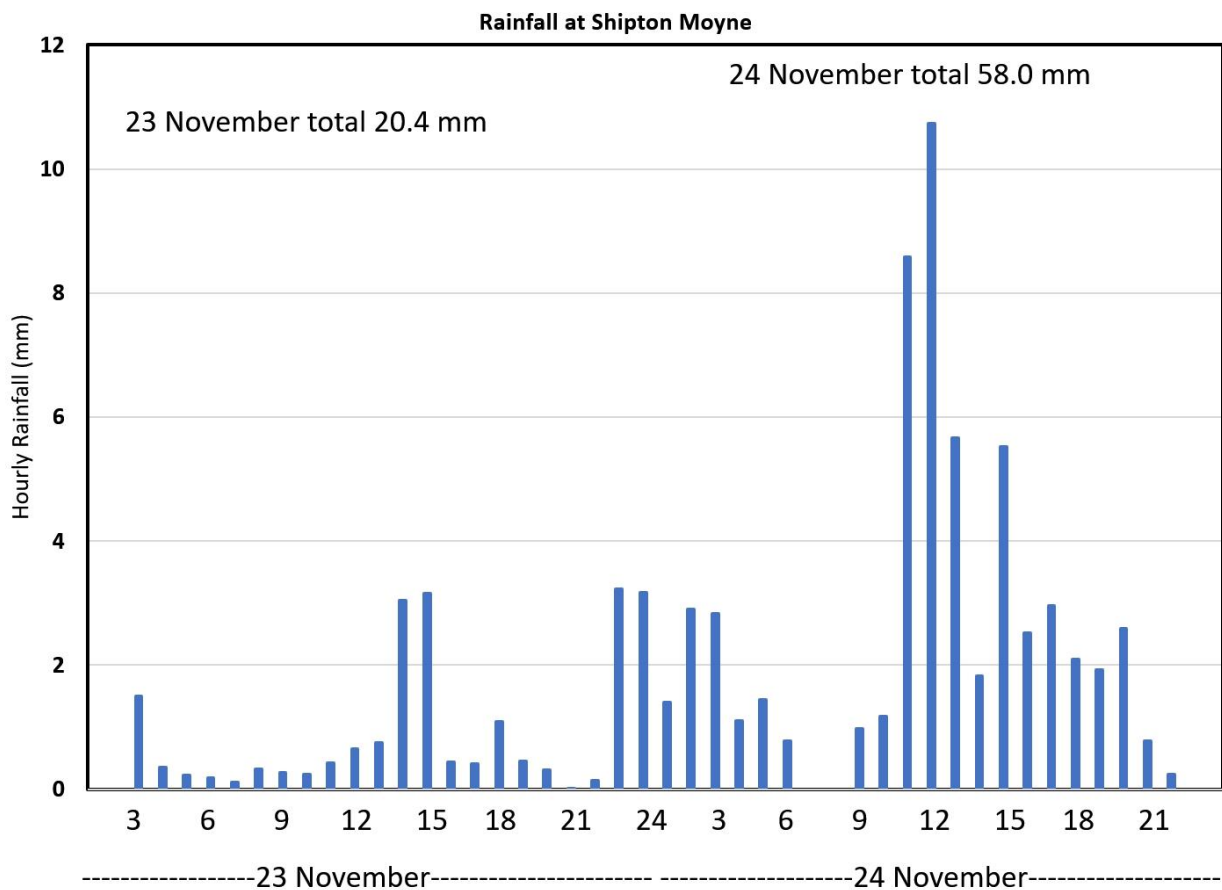
The rainfall at Shipton Moyne over the two days of Storm Bert is shown in Fig. 1. Shipton Moyne is the closest rain gauge to the Lime Down area, about 2.5 km N of Foxley, about 95m OD altitude. Rain started at 3 a.m. on 23 November, and some rain fell on all but 2 hours between then and 11 p.m. on 24 November. The rain was not exceptionally intense (for instance, the UK hourly rainfall record is 92 mm <sup>3</sup>) but unusually persistent. The total for the 24<sup>th</sup> of 58.0 mm qualifies it as an extreme daily value, defined as over 50 mm <sup>4</sup>. A daily rainfall of 50 mm or over would be expected about every 40 years in this area <sup>4</sup>. Since division of the record into calendar days is arbitrary, it can be useful, if there is a continuous record, to calculate the maximum 24-hour rainfall. The 24 hour period up to 21:45 on the 24<sup>th</sup> had the highest 24-hour rainfall during the storm: 64.5 mm. So this was certainly an exceptional rainfall event with 78.4 mm of rain in total during the storm. Rainfall statistics for all three sites are shown in Table 1.

**Fig. 1. Rainfall due to Storm Bert at Shipton Moyne**

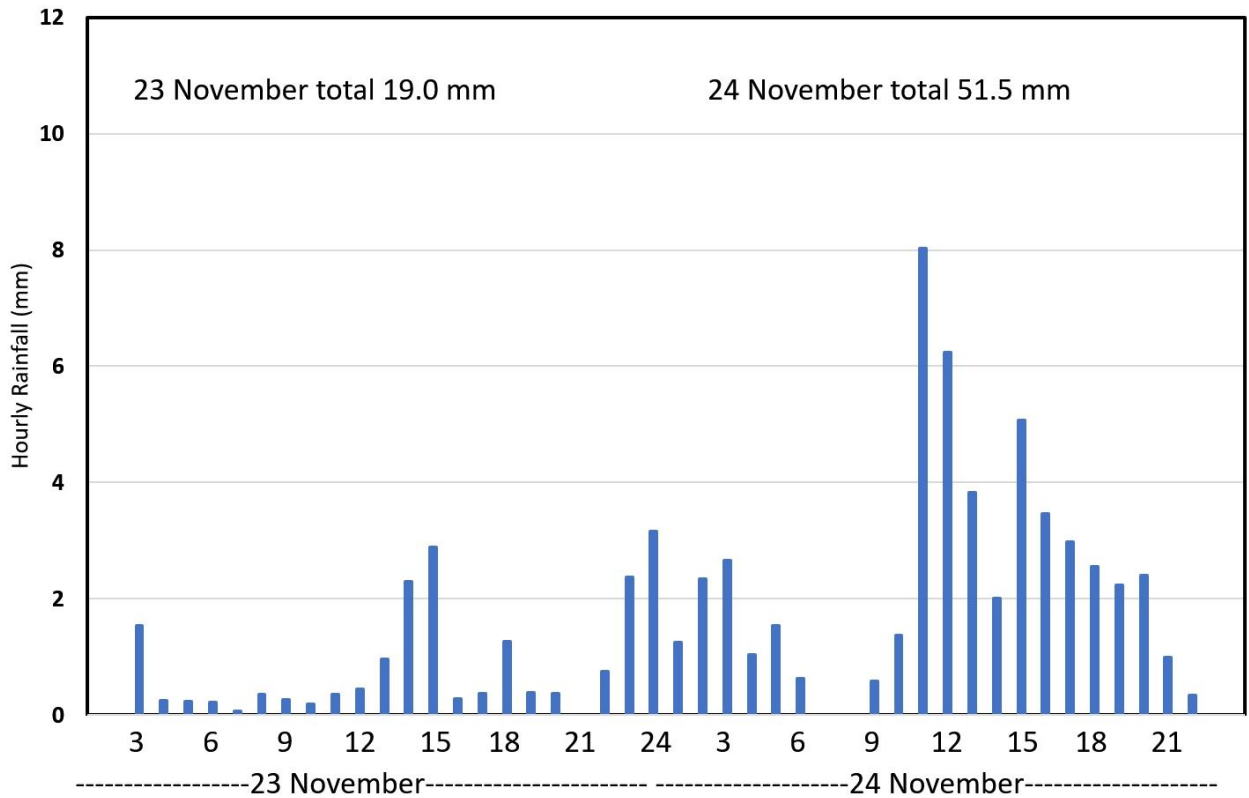
Rainfall at Badminton

Badminton is the next closest raingauge, at 8.3 km SW of Foxley and 115 m OD. The pattern was very similar to Shipton Moyne (Fig.3), but with slightly lower total of 70.5 mm. The peaks at 11:00 and 12:00 are present, but unlike Shipton Moyne the 11 am peak was larger than the 12 am peak, consistent with the storm moving from West to East. There was 51.5 mm on the 24<sup>th</sup> and 19.0 mm on the 23<sup>rd</sup> and the highest 24-hour total was 57.8 mm.

Fig. 3. Rainfall due to Storm Bert at Badminton

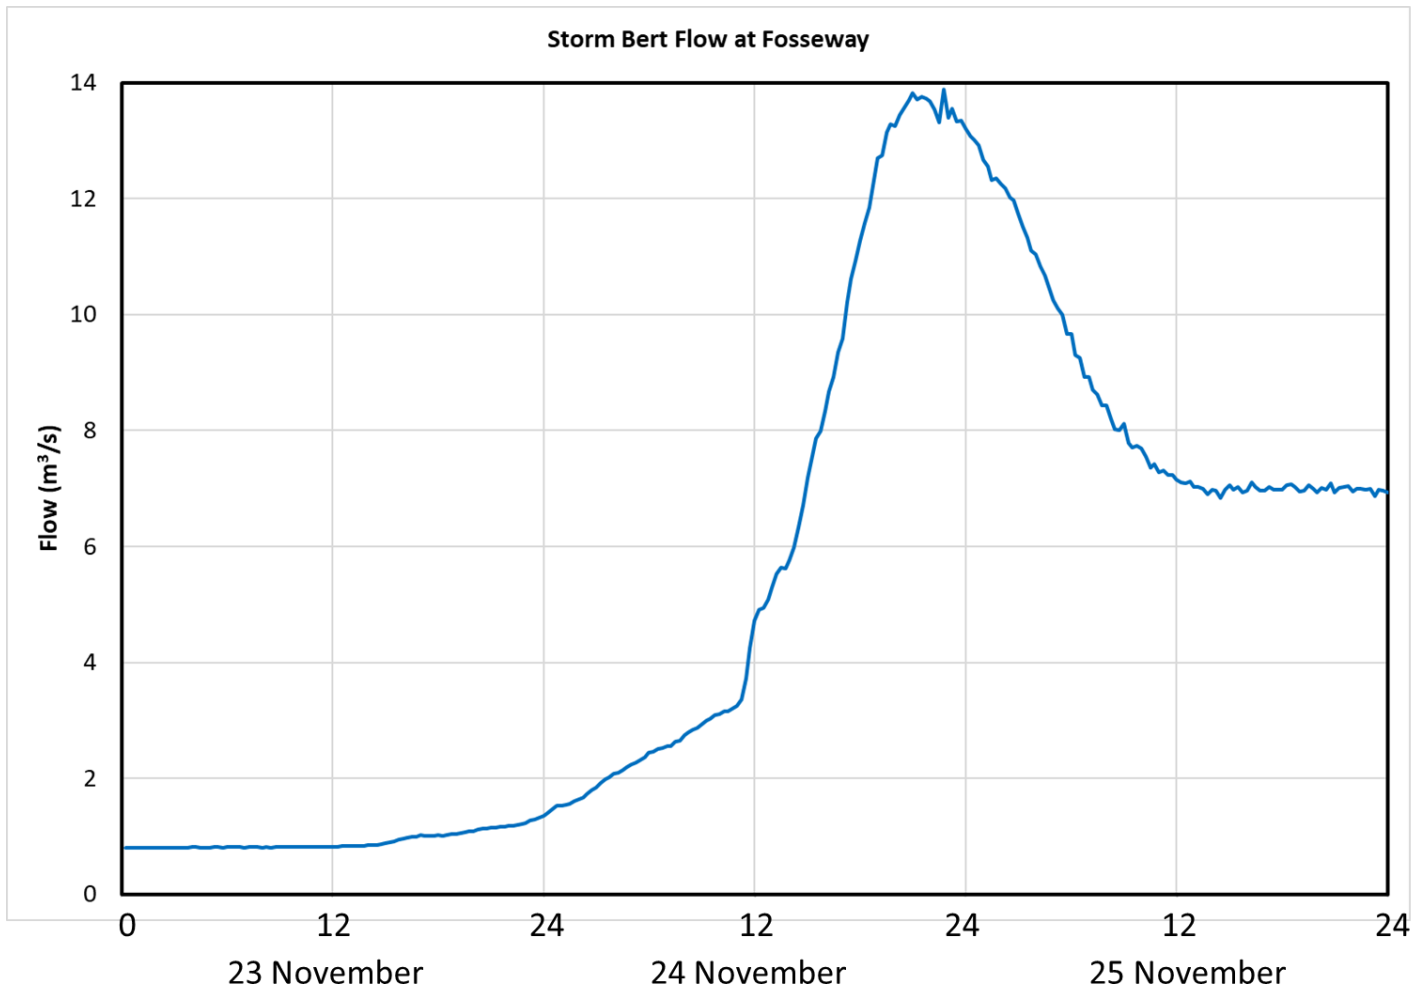
**Fig. 4. Flow in the Sherston Avon at Fosseway during Storm Bert**

The Avon hardly responded to the initial rain of Storm Bert until 2 hours of somewhat harder rain arrived at 14:00 on the 23<sup>rd</sup>. Thereafter there was a fairly slow increase in flow in response to

moderately heavy rain in the small hours of the 24<sup>th</sup>, until the advent of 2 hours of very heavy rain starting at 10:30 of the 24<sup>th</sup> (Figs. 1 and 3). Then there was a sharp increase in river flow which continued to a peak of 13.9 m<sup>3</sup>/s at 22:30, by which time the rain had stopped. Flow then declined until 14:00, when it stabilised at around 7 m<sup>3</sup>/s. A little rain fell about this time, but not enough (< 1mm) to account for the stabilisation, which may be due to the arrival of groundwater flow from higher in the catchment.

The river was in an average state at the beginning of the storm, with a flow of 0.8 m<sup>3</sup>/s, which is about the 44<sup>th</sup> percentile on an annual basis <sup>5</sup> (i.e. 44% of flows are larger than this). The flow stabilised at 7 m<sup>3</sup>/s, which is the 0.2<sup>nd</sup> percentile. Flow records at the site stretch back to 1976, and this is the second highest storm peak: the highest was 18.2 m<sup>3</sup>/s on 25 November 2012 <sup>5</sup>. In view of this it is interesting to ask why downstream flooding was so bad this time compared to 2012 given much higher flows in 2012, although the downstream towns are also influenced by runoff from other catchments.

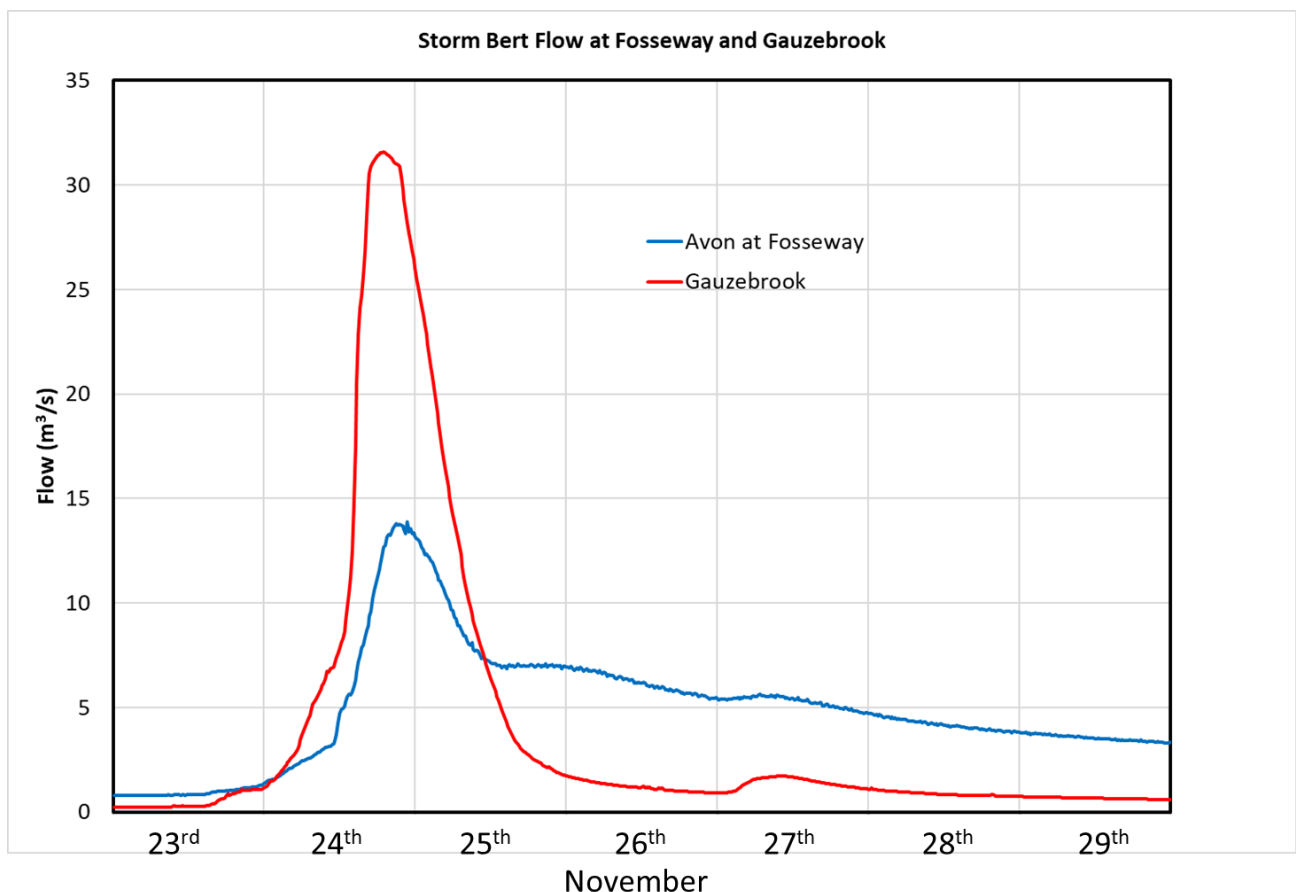
**Fig. 5 Flow in the Sherston Avon and Gauzebrook during Storm Bert**

Flow in the Gauzebrook peaked at 31.58 m<sup>3</sup>/s, 227% higher than the Avon, in spite of the catchment being only 31% of the size (28.2 km<sup>2</sup> as opposed to 89.7 km<sup>2</sup> for the Avon). Peak flow was reached at 18:45, 3.75 hours earlier than the Avon, and the reduction in flow once rain had stopped was

much quicker than the Avon, without the 12 hour period of stabilisation. Inspection of the flow record shows that this pattern is a common one for the Gauzebrook.

As with rainfall, the data are unchecked by official bodies. The Gauzebrook flow peak was calculated from stream height data, which is also available on <sup>2</sup>, and a flow rating curve from 13:30 on the 24<sup>th</sup> to 7:45 on the 25<sup>th</sup>. The rating curve was constructed from the relationship between flow and stream height in the two days before the storm. Flow gauges often fail or are partially bypassed during extreme storms, but these data look credible.

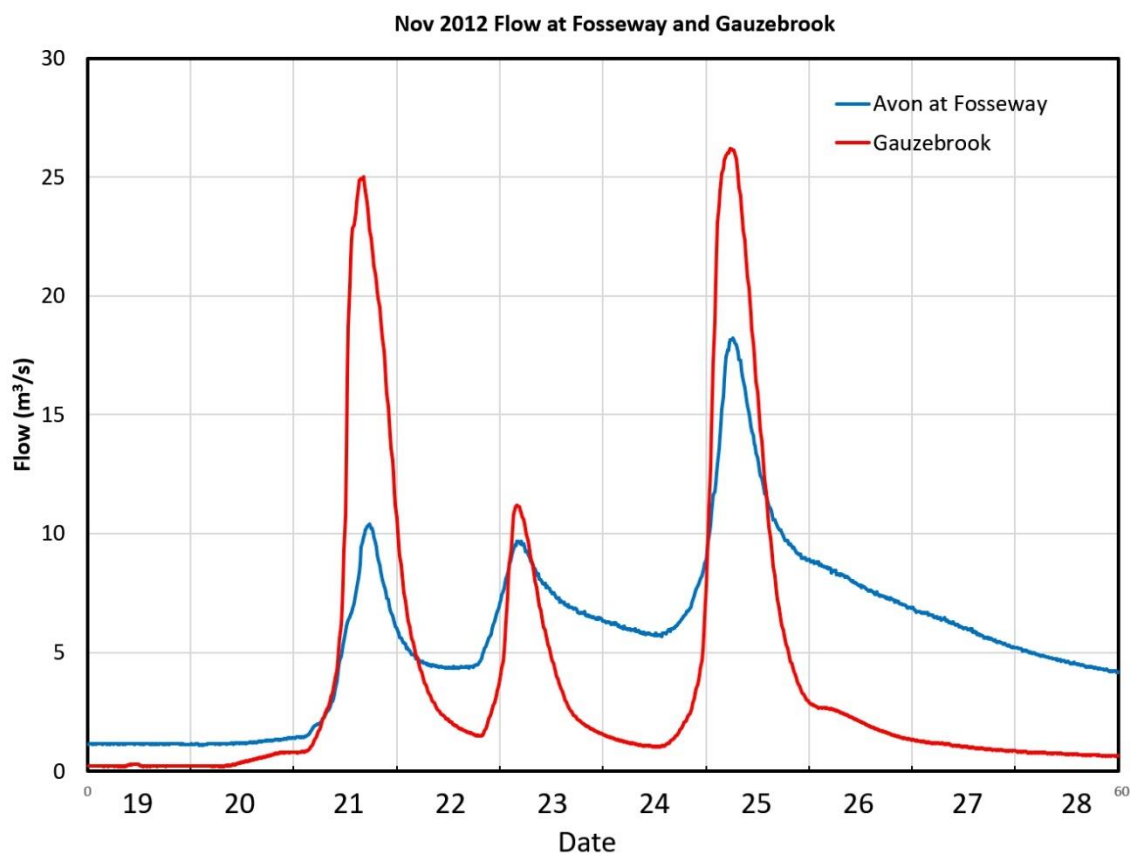
**Fig. 6 Flow in the Sherston Avon and Gauzebrook in November 2012**

The November 2012 storms were a more complex event than Storm Bert, with three separate storm peaks. The pattern is similar to Fig. 5, with the Gauzebrook rising and falling more quickly than the

Avon, and a larger flow peak. The cumulative effect of the three events can be clearly seen in the Avon. The recession curves become shallower after each event. This probably indicates outflow from groundwater and soil water sources which have been topped up by the storms. These sources are evidently less important for the Gauzebrook.

At the beginning of the storm pattern on the 19<sup>th</sup>, the Avon at Fosseway was higher than it was for Storm Bert, with a flow of 1.14 m<sup>3</sup>/s as opposed to 0.8 m<sup>3</sup>/s, which is 32% exceedance (32% of flows are higher than this) as opposed to 44% for Storm Bert.

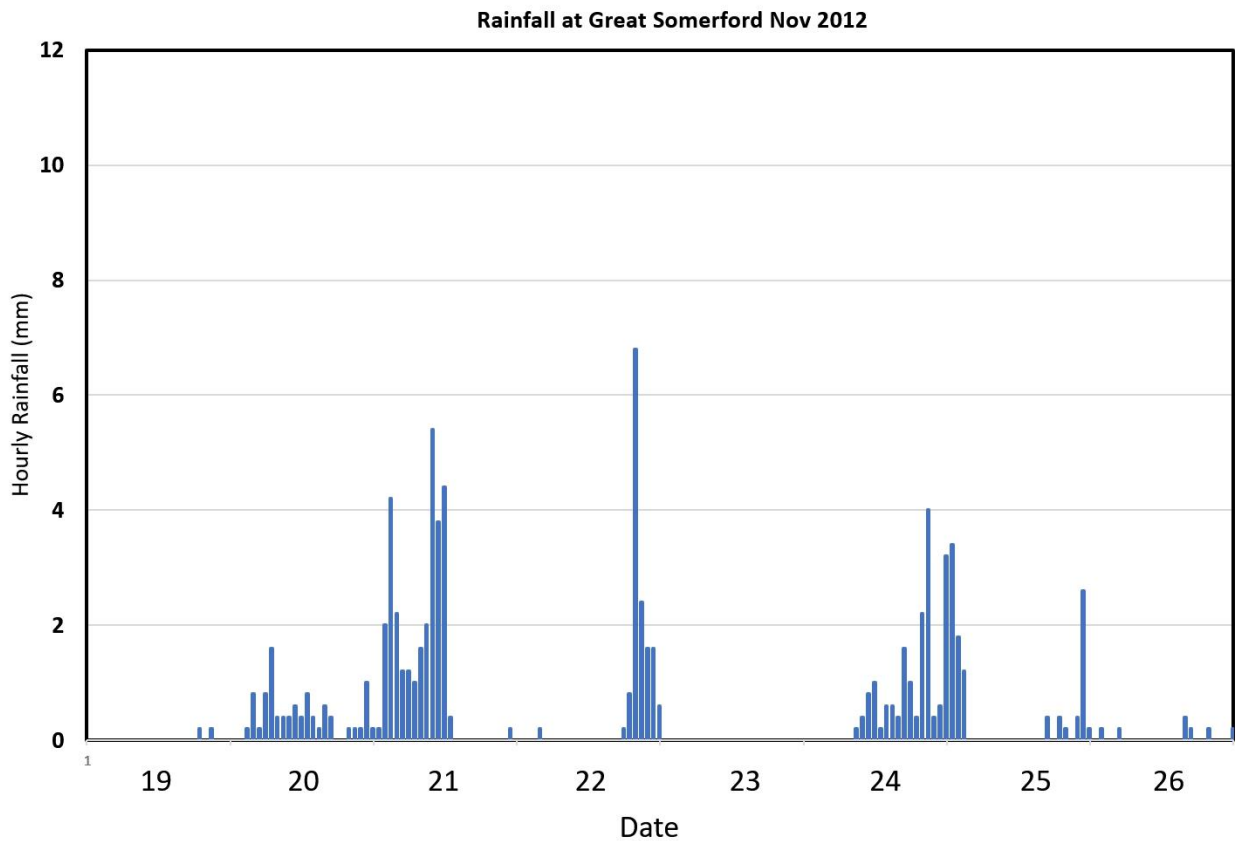
Hourly rainfall at Great Somerford over the same period is shown in Fig. 7. The scale is the same as Figs 1-3. Though the pattern of rain leading to the three flow episodes can be clearly seen, there are no very high values at the time of the final record flow peak, unlike in Figs 1 and 3. In the database<sup>2</sup>, the rainfall during this period at Great Somerford is marked as "suspect" although it is not clear why. Table 2 shows daily rainfall for four local sites. Great Somerford has a very similar pattern to Tetbury, though the absolute amounts are lower. At Shipton Moyne and Badminton, however, there is no rainfall on the 24<sup>th</sup> and 25<sup>th</sup> which would explain the extreme flow peak on the 25<sup>th</sup>, which contradicts rainfall records at the other two sites (and my own memory of the event).

**Fig. 7 Rainfall at Great Somerford, November 2012**

Either there was some rather extreme spatial variation in rainfall on those days or the raingauge records are inaccurate. At none of the raingauge sites did the daily totals exceed 50 mm in the November 2012 event, nor did the 24-hour maximum totals (43.4 mm for Tetbury on the 21<sup>st</sup> being the largest).

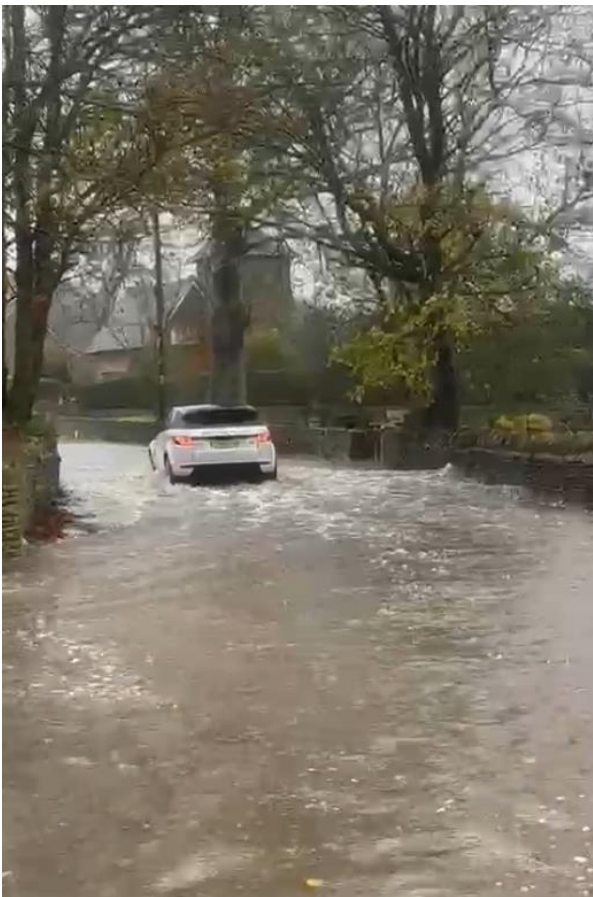
**P1. Alderton Main Street.**

Just west of Lime Down Area C.

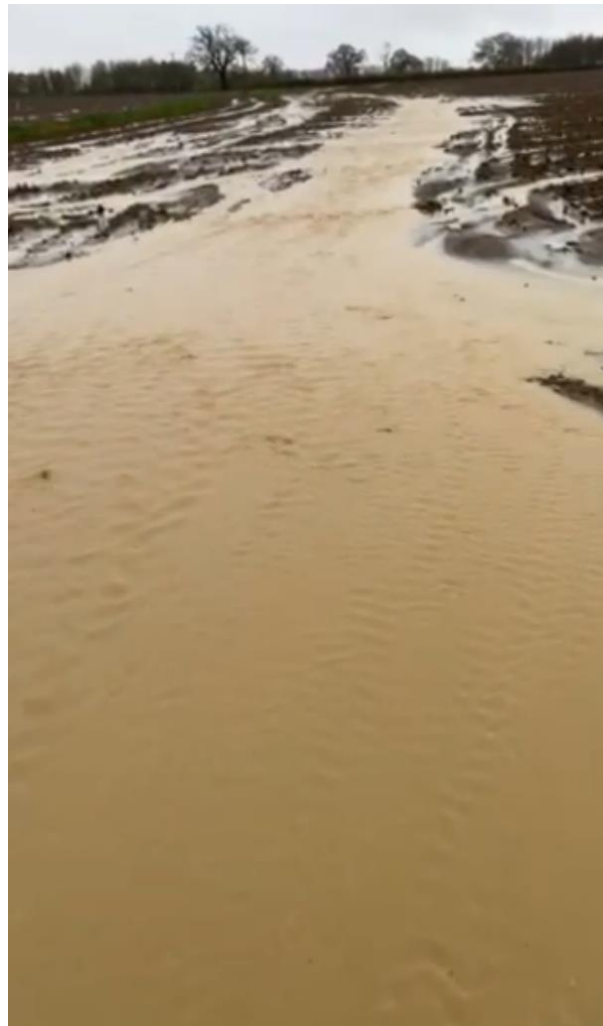
**P2. Looking W into Area C from Farleaze.**

Land shown in P2 is in EA Flood Zone 1 (<0.1% risk of flooding per year). Surface runoff over saturated ground and concomitant soil erosion can be seen.

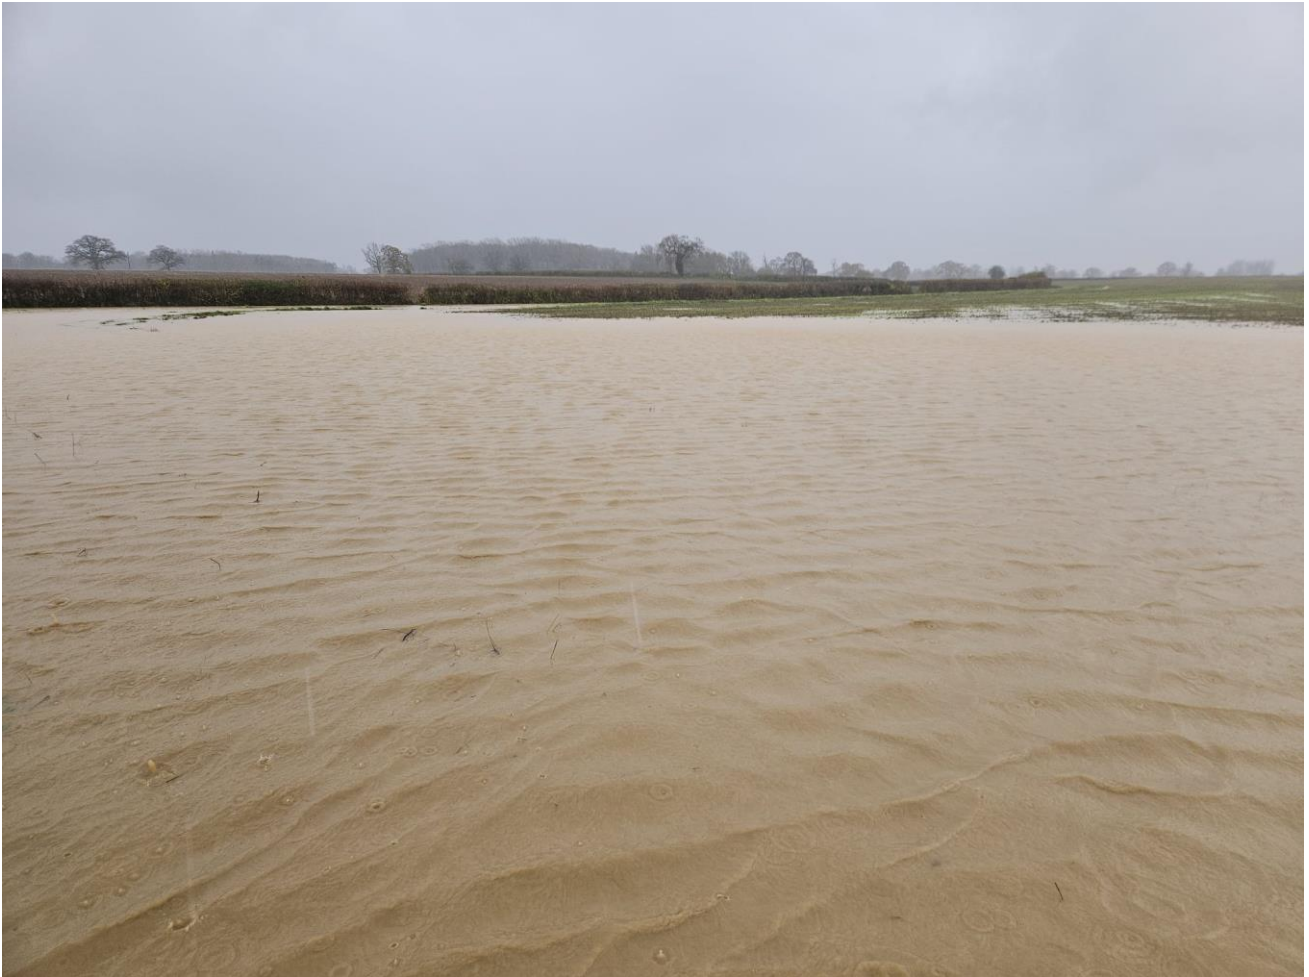
**P3. Flooding on Area A the day after Storm Bert. Dated 26.11.24 at 10:52.**

Land shown in P3 is in EA Flood Zone 1 (<0.1% risk of flooding per year). These fields are mostly scheduled for panels (Area A) at the time of writing. Saturated ground in the background can be seen draining down the slight slope into the surface water, which is backed up against a field boundary.

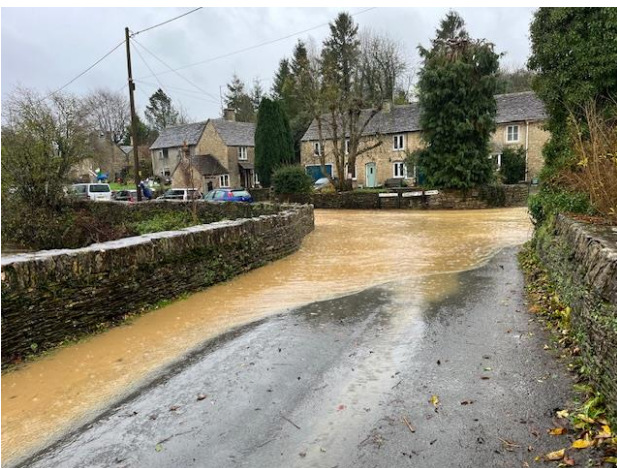
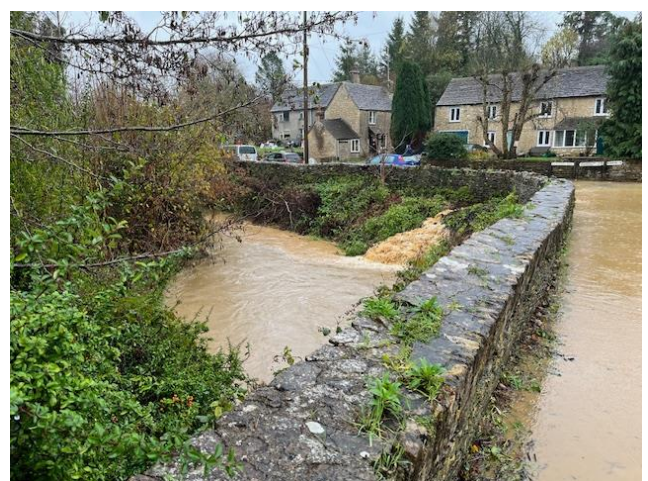
**P4 and P5 Tanners Hill Bridge, Sherston.**

Runoff from Area A is contributing to water running down the roads to the right and left of the houses, and can be seen pouring into the Avon in P5.

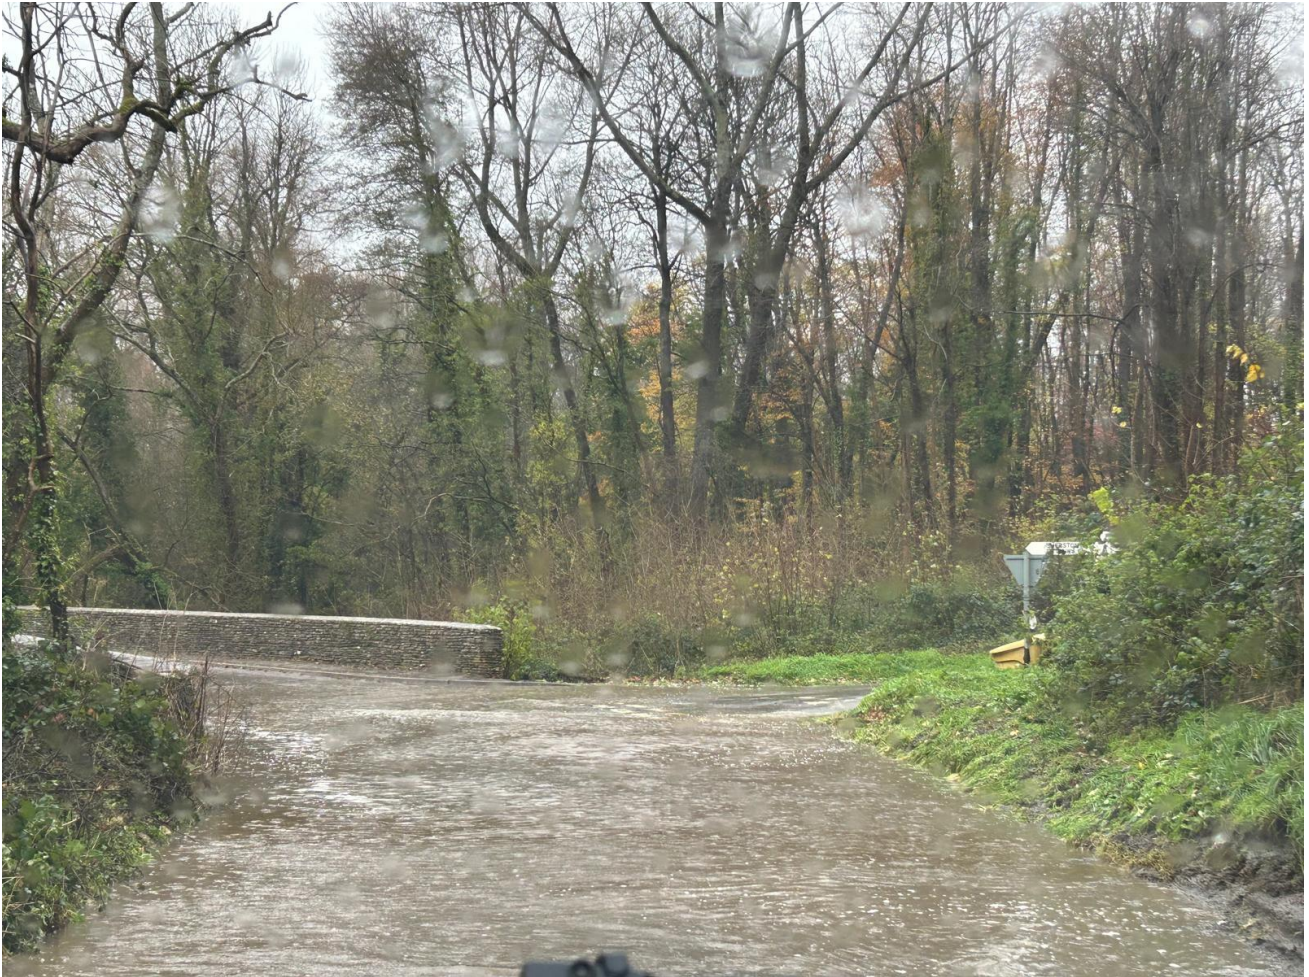
### **P6 Folorn Bridge, Sherston, during Storm Bert**

Runoff from Area A is contributing to water flowing down the road to the right and the road behind the camera.

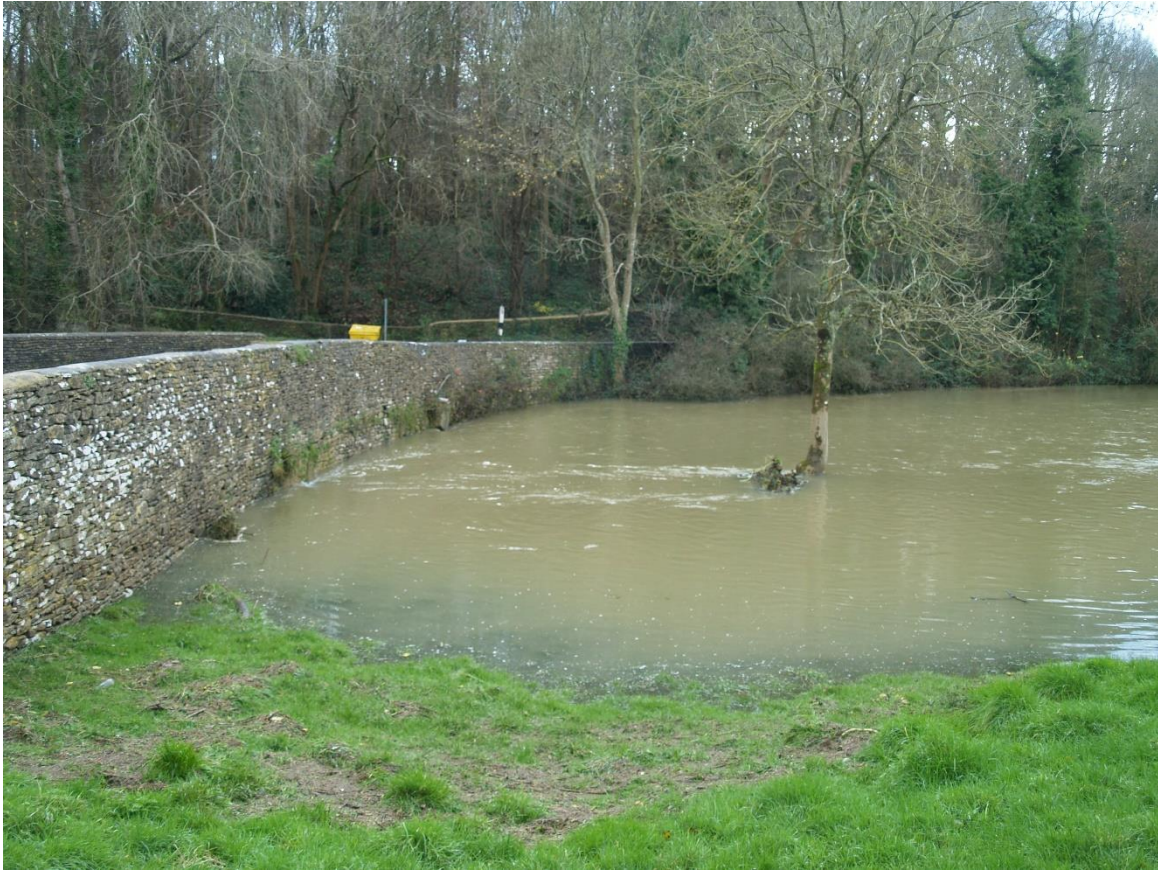
There are no photographs of the underside of Folorn Bridge during Storm Bert. However, there are pictures from the 2012 flood event. Pictures P7 and P8 show the situation as the third flow peak of November 2012 was receding. Flow at the time was  $13.0 \text{ m}^3/\text{s}$ , very close to the Storm Bert flow peak of  $13.9 \text{ m}^3/\text{s}$ , so the situation was very probably similar. The two arches of the bridge are almost completely submerged. In 2012, the flow peak was  $18.2 \text{ m}^3/\text{s}$ , 29% higher than in the photograph.

**P7 Folorn Bridge, 25.11.2012, 12:00.**

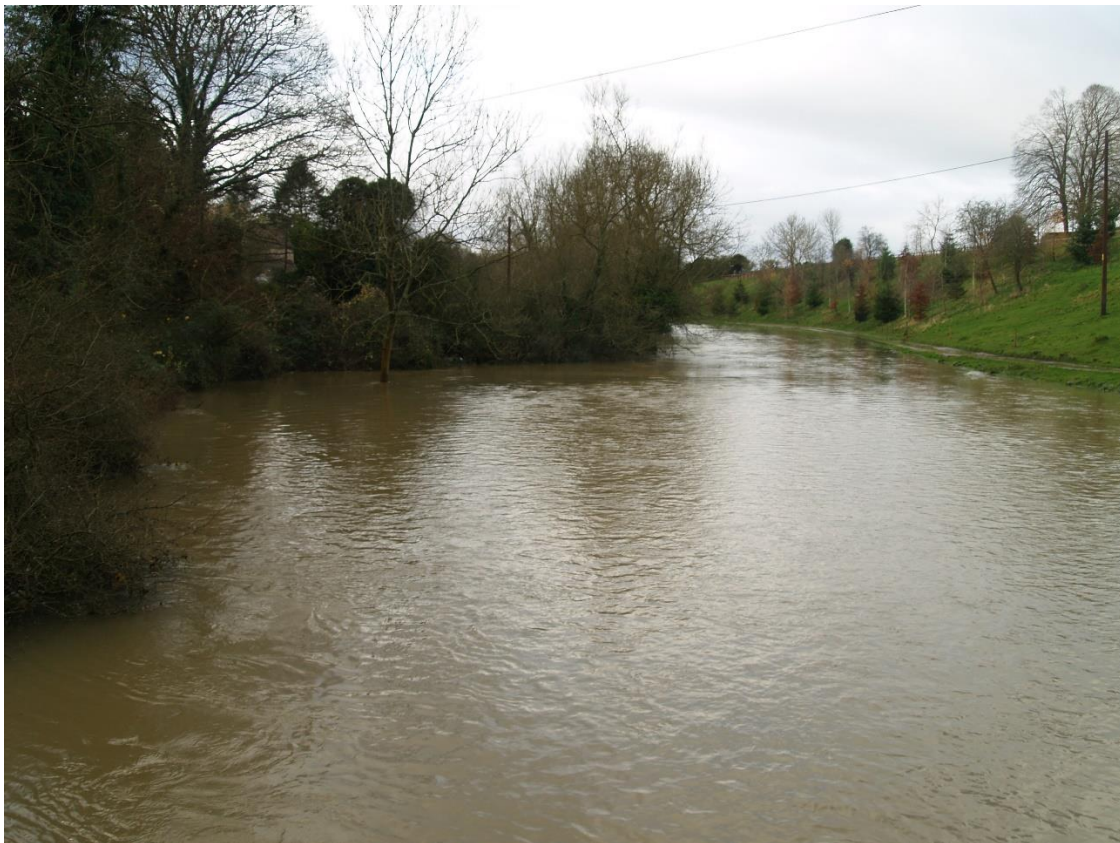
Flow restriction at Folorn Bridge causes the water to back up as shown in P8. The inundated area is in EA Flood Zone 3 (>1% risk of flooding per year). Wessex Water's Sherston sewage treatment works is just out of sight in the distance. Though the water retention here could be providing some flood protection for Malmesbury downstream, it must also be putting the bridge at risk.

**P8 Above Folorn Bridge, 25.11.2012, 12:01.**

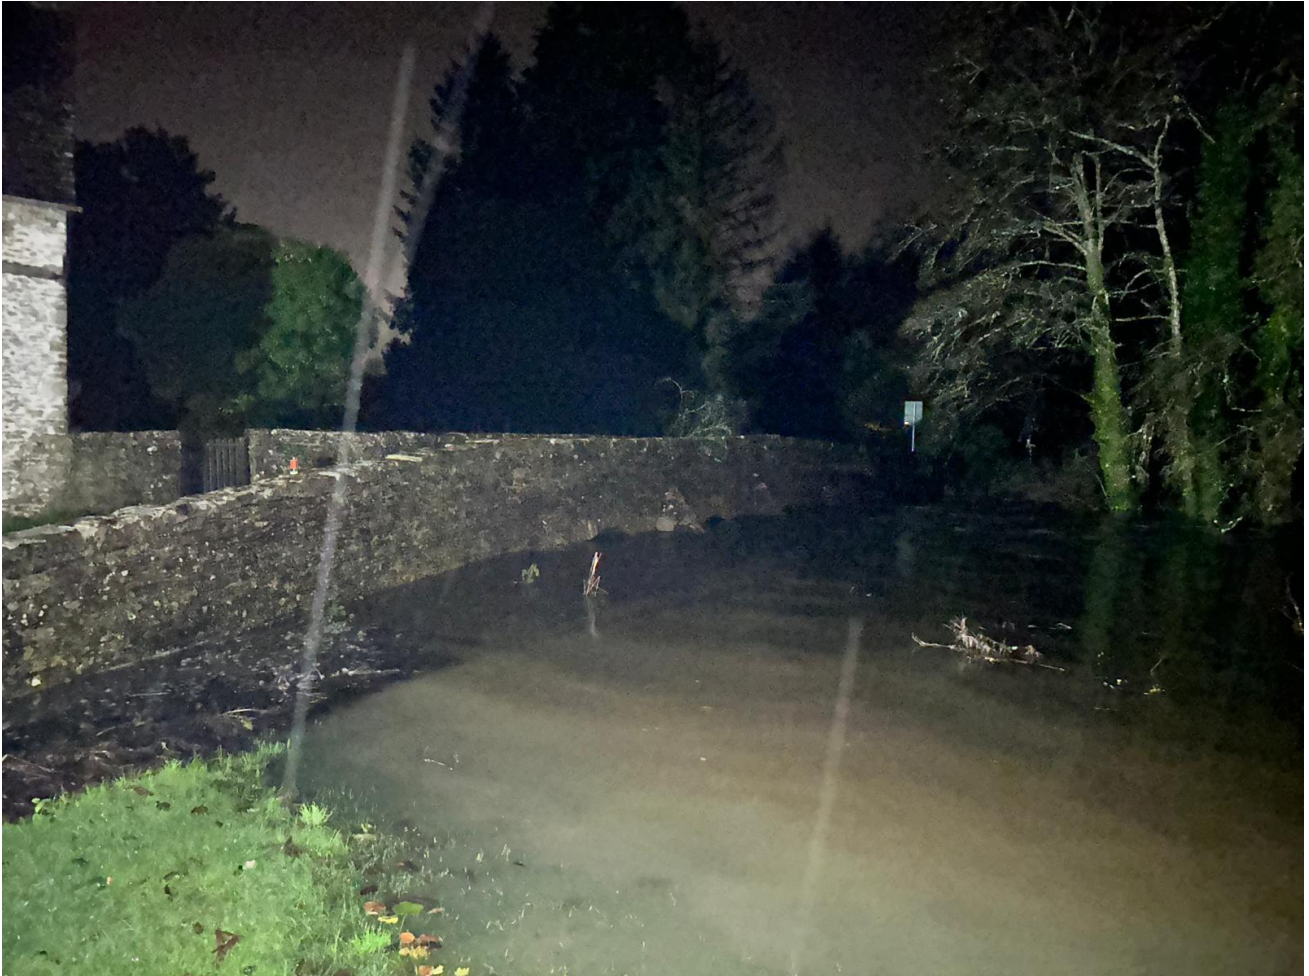
A little further downstream, the bridge at Easton Grey was also almost submerged by Storm Bert (P9). This was about an hour before the Storm Bert flow peak, which was 15 cm higher.

**P9 Easton Grey Bridge, 24.11.2024, 21:38.**

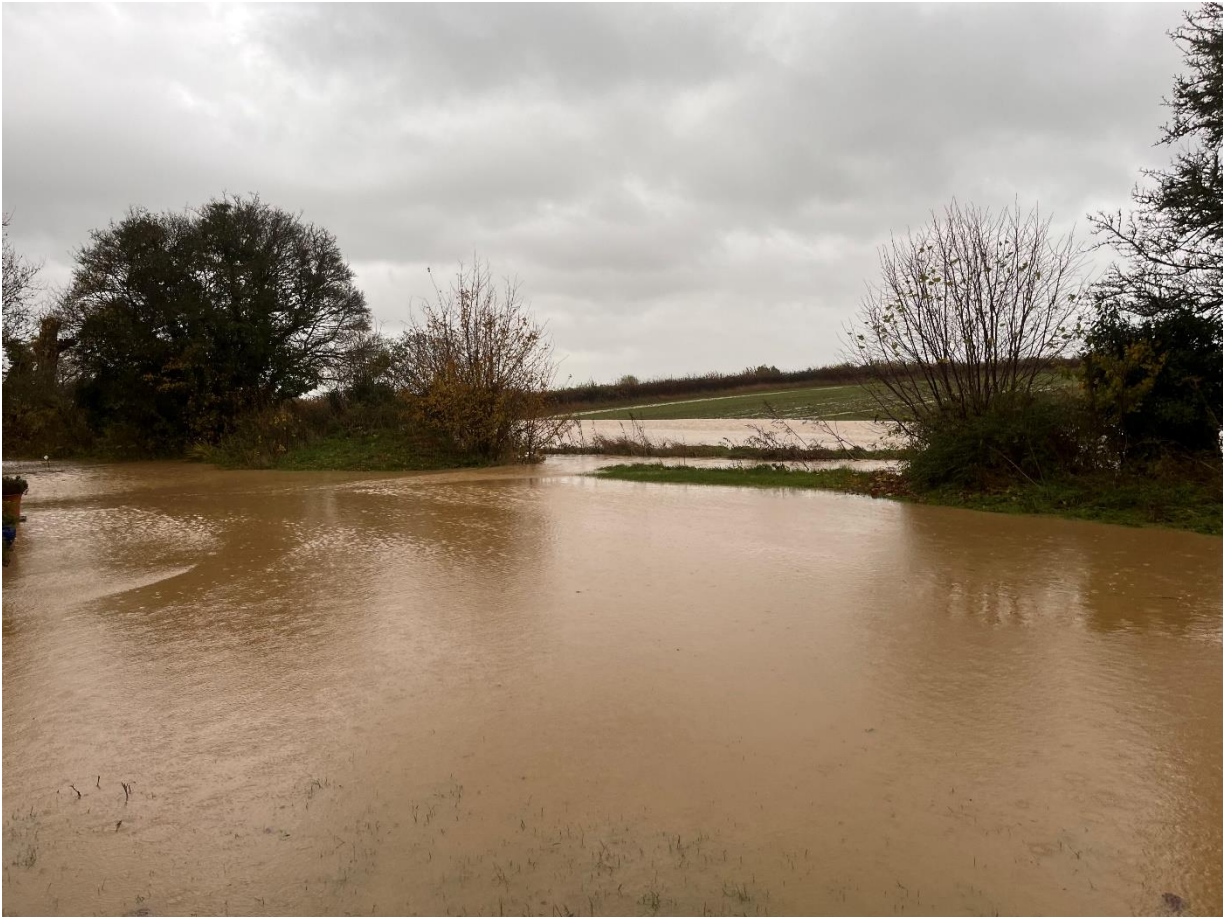
P10 below shows flooding in Lime Down Area C. The ephemeral watercourse behind the hedge is in EA Flood Zone 3, and the field beyond (which will have panels) in Flood Zone 1. The watercourse will feed runoff from Area C into the Avon near Foxley. Surface runoff can be seen flowing down the saturated soil in the field.

**P10 Flooding at Fosse Farm due to Storm Bert.**

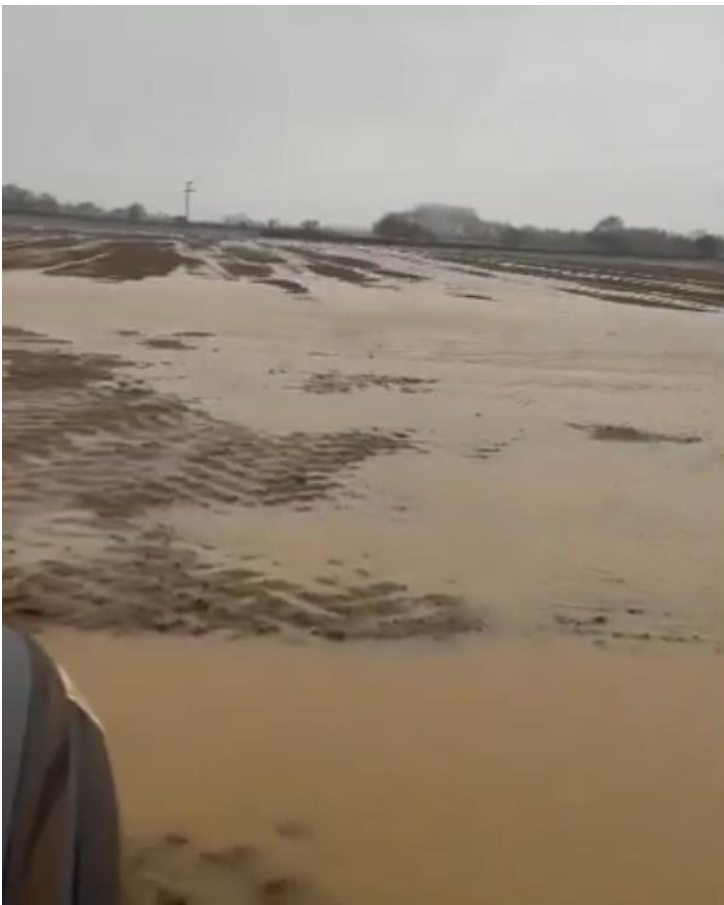
**P11 Flooding due to Storm Bert between Foxley and Norton**

This field is due to be covered in solar panels as part of Lime Down Area B. It is in EA Flood Zone 1 (<0.1% risk of flooding per year). There are signs of compaction by agricultural machinery in the foreground.

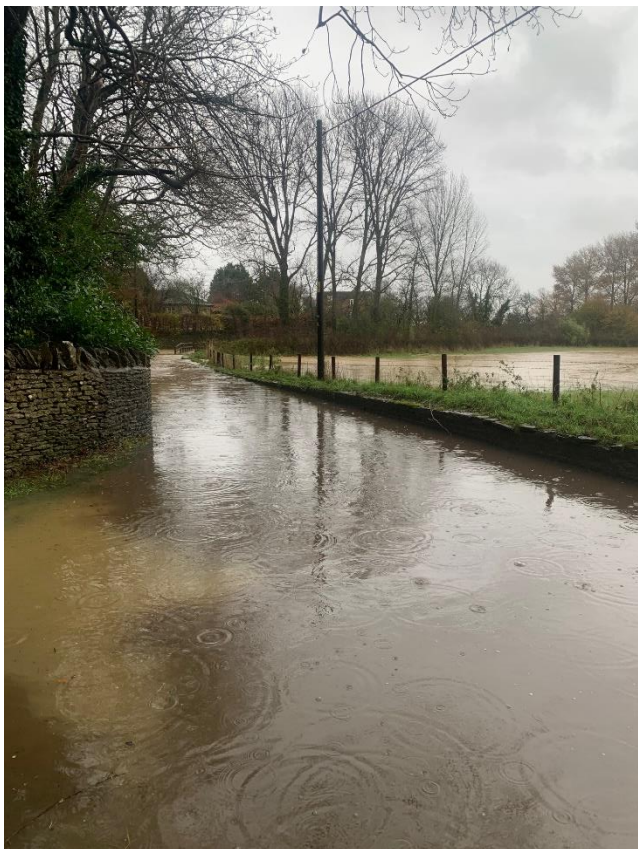
P12 and P13 show the Splash at Norton, a small bridge which overflows onto a normally dry ford on the small stream which will drain Area C and part of Area B into the Avon near Foxley.

**P12 The Splash at Norton, Storm Bert**

P12 is the view towards the Vine Tree public house with the Splash in the distance. P13 shows the Splash itself, with the stream running from right to left towards the fenced structure, which is a submerged bridge. The depth was recorded variously as between 0.55 and 1.2 m. A car failed to pass the ford later in the day and was abandoned.

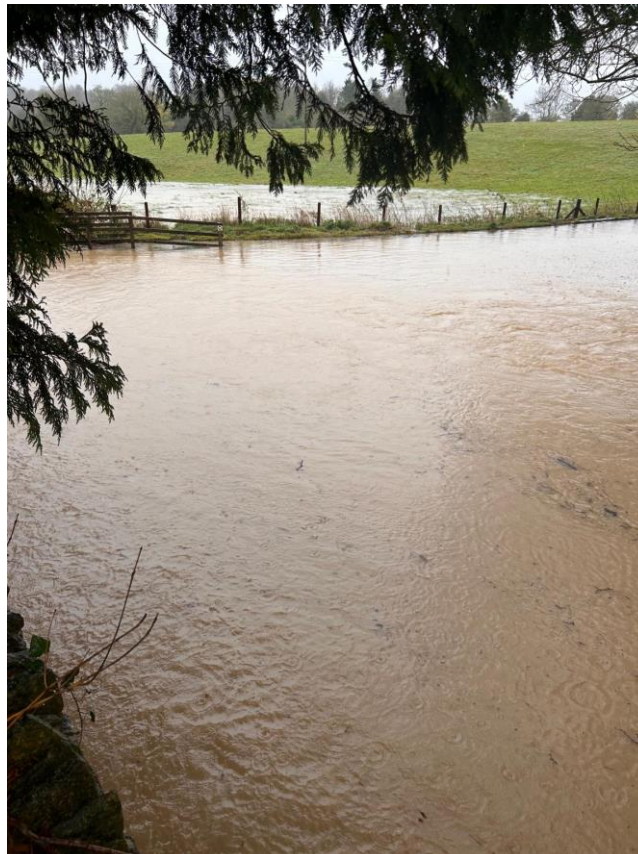
**P13 The Splash at Norton, 24.11.2024, 12:51**

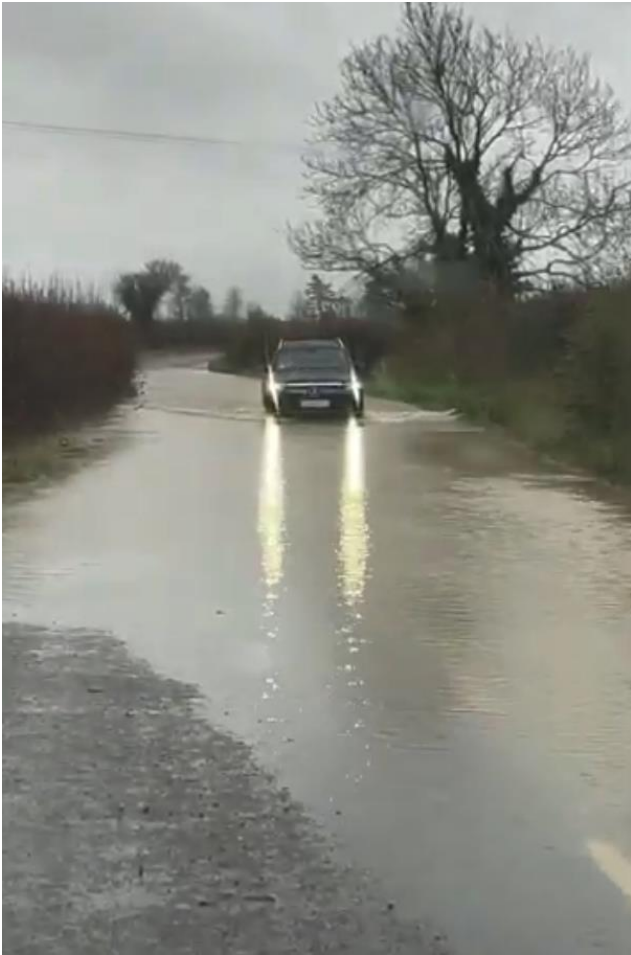
P14 below shows a stretch of road between Hullavington and Norton near Bradfield Manor. This stretch frequently floods after heavy rain. Proposed BESS site on the left, Area D on the right. Both sides are in EA Flood Zone 1.

**P14. Hullavington Norton road, Storm Bert**

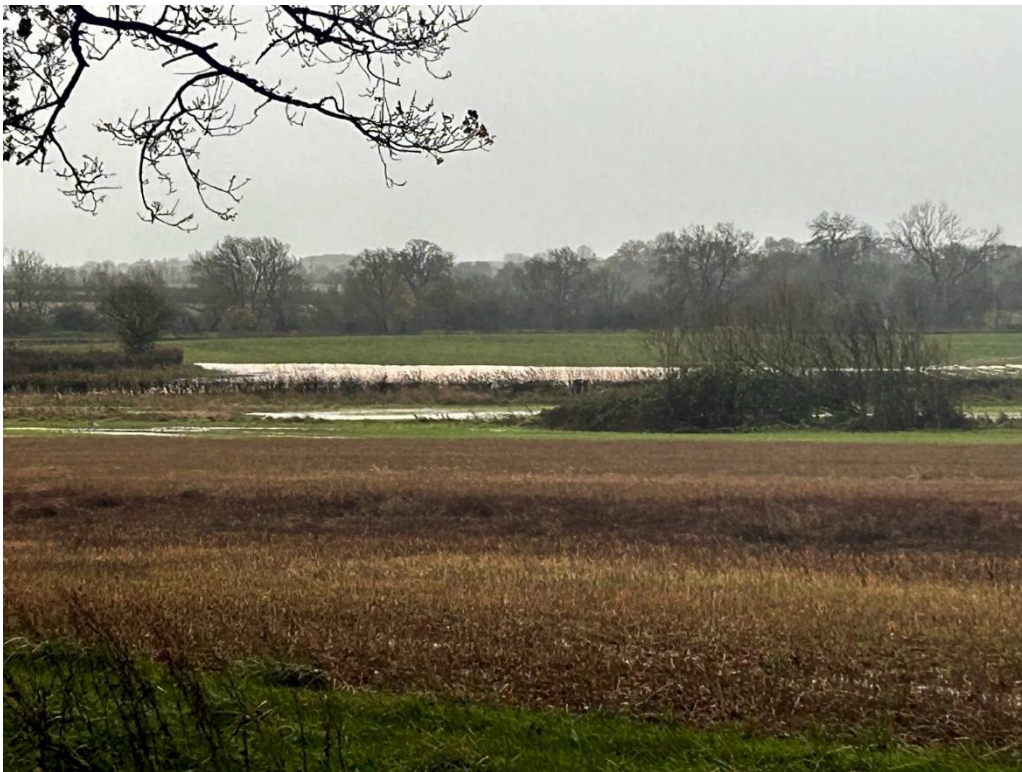
P15 below is close by, looking over fields in Area D. Most of the picture is in Flood Zone 1, but the ephemeral watercourse in front of the hedge is Flood Zone 3.

**P15 From Bradfield Wood 24.11.2024. 11:50.**
