# “Storm Bert” and Flooding on the Site of the Lime Down Solar Park.

## Summary

It is proposed to construct a very large solar farm, called Lime Down Solar Park, in part of the South Cotswolds in North Wiltshire. A named storm, Storm Bert, caused extensive flooding in this area in 2024. This report contains a brief analysis of the rainfall that caused the floods, the effects on flow in the rivers, a comparison with a previous major flood event in November 2012, and an annotated pictorial account of the floods themselves.

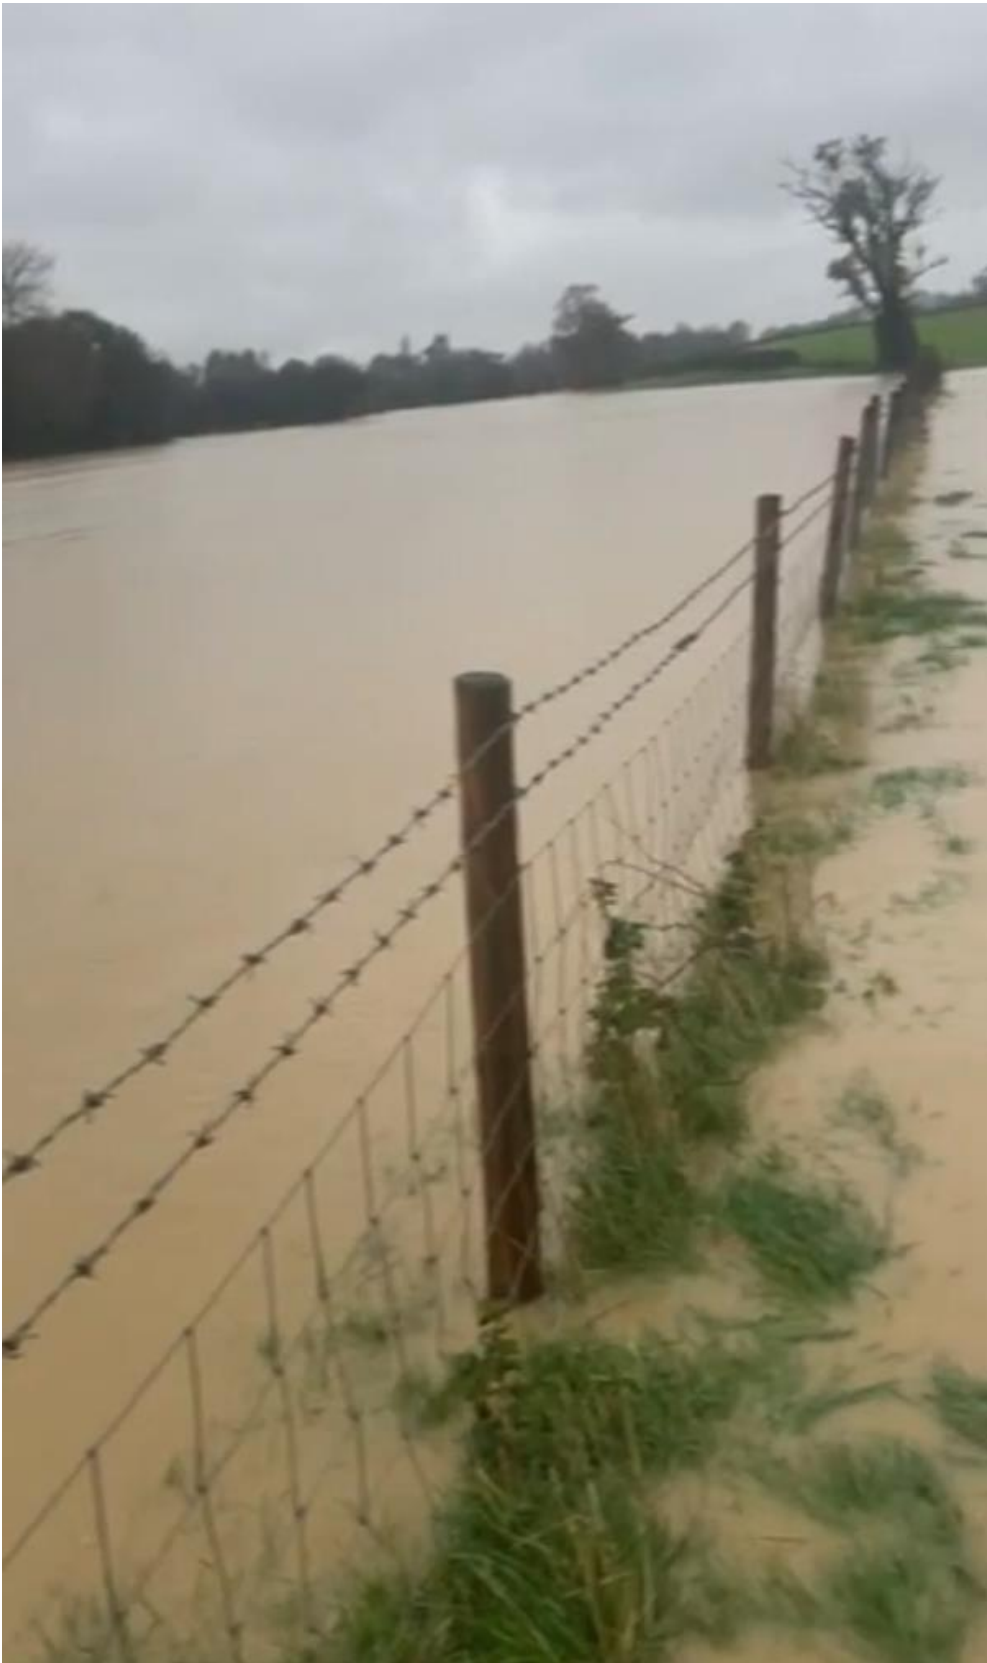
The Gauzebrook provided some of the most spectacular images of flooding. P16 shows the Gauzebrook valley above Corston. The left side of the picture is scheduled to be covered in solar

panels at the extreme end of Area D. All of Area D and the BESS would drain into this area. The entire inundated area in the picture is in Flood Zone 3.

**P16 The Gauzebrook above Corston.**

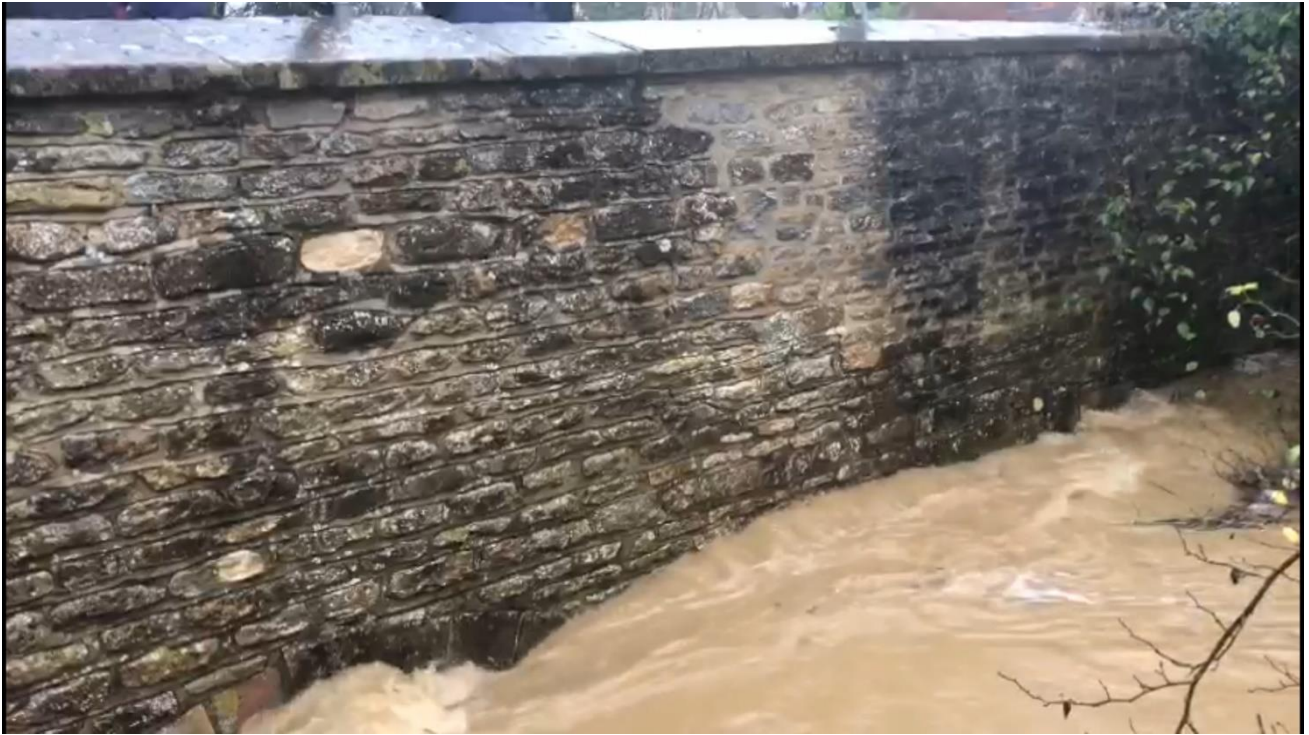
**P17 Corston Road Bridge, Storm Bert**

P17 shows the Gauzebrook flowing under the main A429 Malmesbury – Chippenham road. The top of the arches can just be seen.

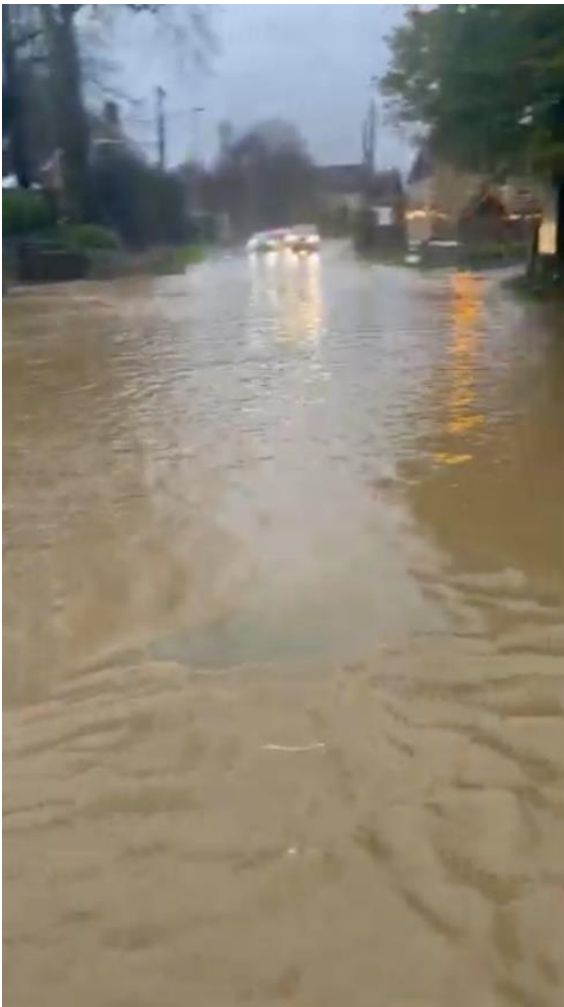
**P18. A429 at Corston during Storm Bert.**

On the surface, the Gauzebrook flooded onto the main road, which was closed for a while (P18). This situation occurs even when the flooding is not so extreme.

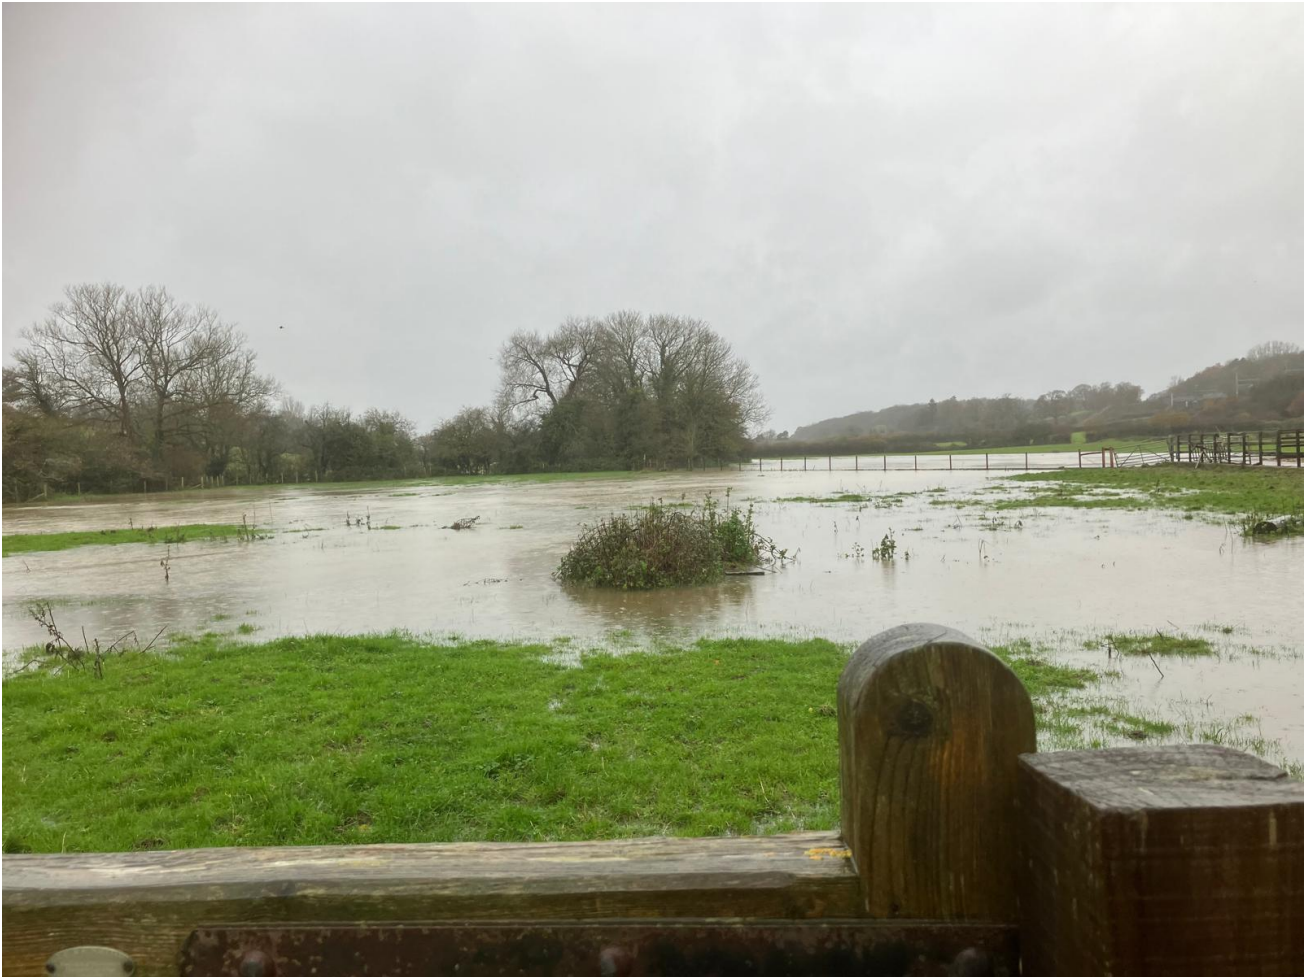
#### **P19 Rodbourne Bottom after Storm Bert.**

Area E drains into Rodbourne Bottom. The Rodbourne Brook runs behind the fence to the left. The Area pictured is in Flood Zone 3. No panels are scheduled here, but they do occupy part of Flood Zone 3 higher up the valley.
